Precision Home Inspection of the Twin Tiers, LLC  
3602 Wyncoop Creek Rd  
VanEtten, NY 14889

# Home Inspection Report

123 Anywhere St.  
Southern Tier, NY 14889

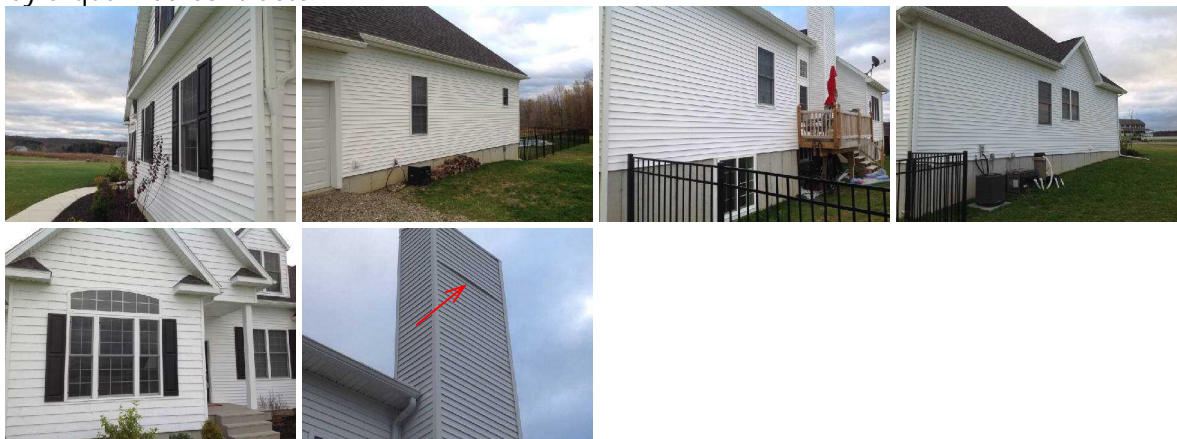
2. Main Exterior Surface Type: Vinyl siding - Siding has pulled loose at rear chimney location. Recommend repair by a qualified contractor.

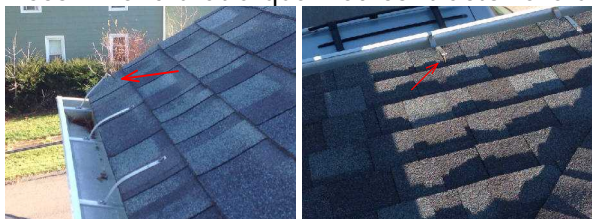
3. Gutters: Aluminum - There were a few places where gutter attachments were loose and need reattachment. Recommend that a qualified contractor evaluate and repair.

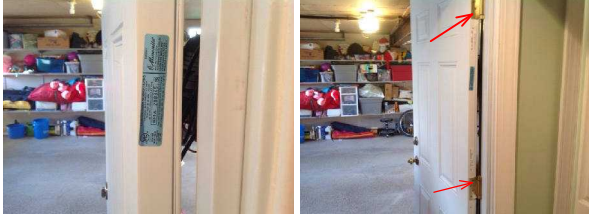
4. Attached Garage Service Doors: Metal - It is recommended that service doors between house and garage have automatic closers or spring hinges for safety reasons. Recommend installation by a qualified contractor.

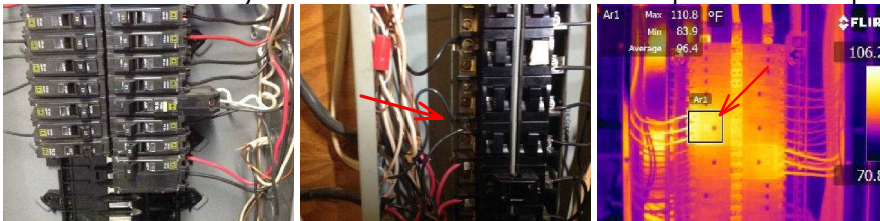
1. Basement Electric Panel Breakers: Copper - Double taps are present at breakers. These circuits need to be moved to their own circuit breaker and cannot share a breaker. It is recommended that a qualified electrician inspect the new circuits and properly connect the new circuits to an individual breaker for each circuit. One breaker is currently overloaded and needs to be inspected and repaired by a qualified electrician.

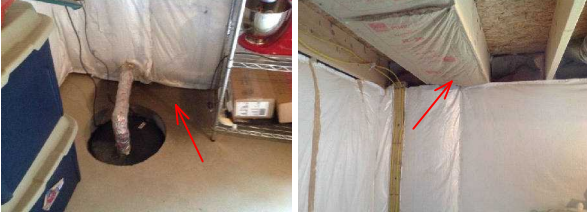
5. Main Basement Sump Pump: Submerged - Sump pump piping has a leak at ceiling level behind insulation. Insulation is wet and will need to be replaced. Recommend repair by a qualified contractor.

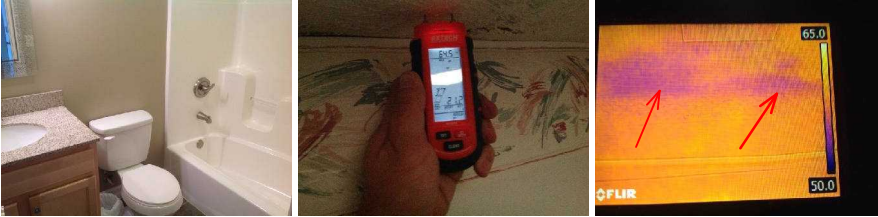
7. Master Bathroom Ceiling: Paint - Ceiling has high moisture content, moisture content at 21.6 %. Appears that skylight in bathroom has a leak. Recommend that a qualified contractor evaluate and repair.

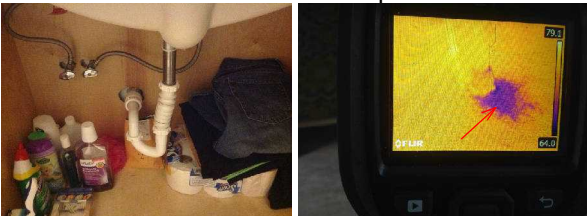
9. Master Bathroom Faucets/Traps: Moen fixtures with a PVC trap - Leaking trap, A licensed plumber recommended to estimate repairs.

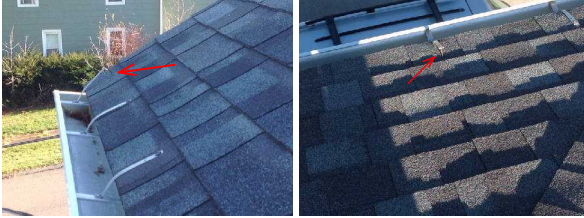
11. ☒☐☐☒☐ Gutters: Aluminum - There were a few places where gutter attachments were loose and need reattachment. Recommend that a qualified contractor evaluate and repair.

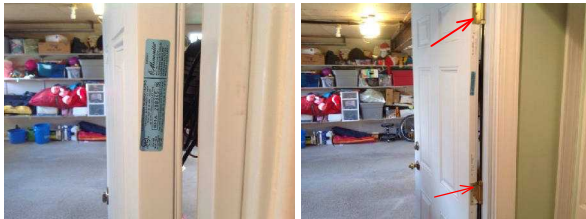
8. ☒☐☐☒☐ Service Doors: Metal - It is recommended that service doors between house and garage have automatic closers or spring hinges for safety reasons. Recommend installation by a qualified contractor.

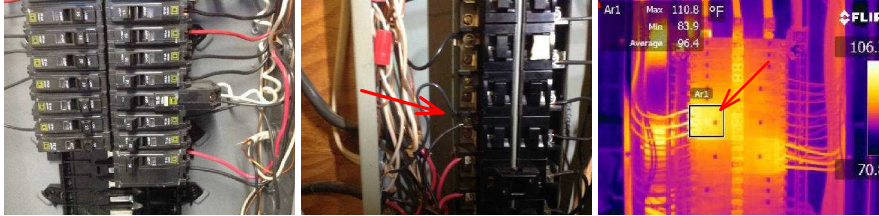
12. ☒☐☐☐☒ Breakers: Copper - Double taps are present at breakers. These circuits need to be moved to their own circuit breaker and cannot share a breaker. It is recommended that a qualified electrician inspect the new circuits and properly connect the new circuits to an individual breaker for each circuit. One breaker is currently overloaded and needs to be inspected and repaired by a qualified electrician.

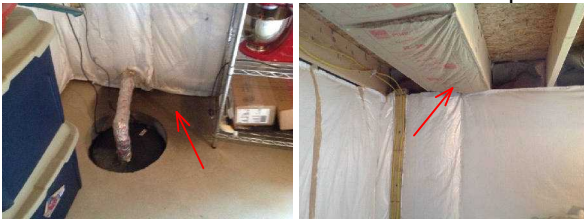
14. ☐☐☐☐☒ Sump Pump: Submerged - Sump pump piping has a leak at ceiling level behind insulation. Insulation is wet and will need to be replaced. Recommend repair by a qualified contractor.
