Property Inspection Report

123 Somewhere St
Yourtown NY 14999

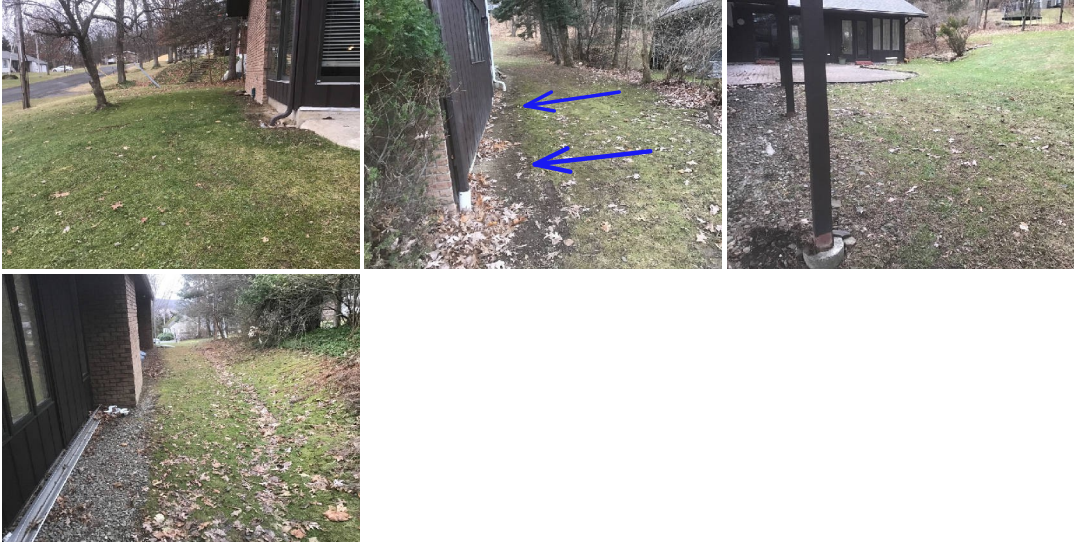
1. Grading: Minor slope, Flat - Flat- The grading is flat in some areas, use caution and monitor for pooling against foundation. Improvement of grade may be necessary to direct water away from the structure.

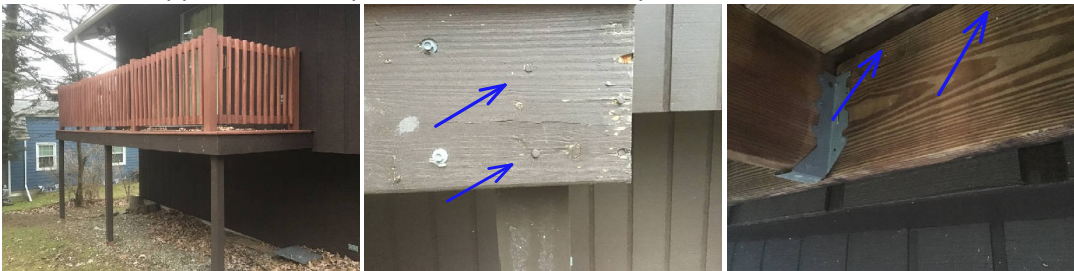
2. Balcony: Stained wood - No Flashing- No flashing is visible at ledger board of deck. This condition may allow water to be trapped between deck and structure. It is very difficult to add flashing after deck is built and may have not been required when constructed. The inspector recommends diligently monitoring for moisture and/or installation of flashing.

Support attachment- Improper attachment to supports. Lag bolts or screws are typically used to attach to any structural supports. The inspector recommends repair as directed.

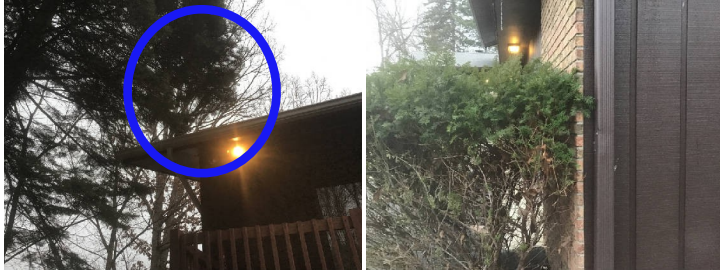
3. Vegetation: Trees, Shrubs - Overhanging limbs- Tree limbs over hang the roof and should be cut back. Tree cover can cause early failure of roof surface and damage from falling limbs. The inspector recommends trimming limbs.

Overgrown- Vegetation around the exterior walls was overgrown and close to in contact with structure. Trimming to 18 inch minimum clearance to avoid related concerns is recommended.

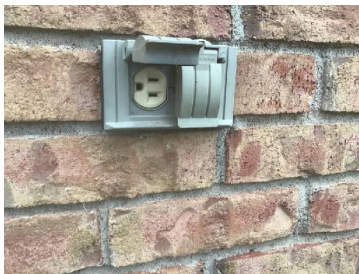
4. Exterior Electric Outlets: 110 VAC - Weather protected, non- GFCI- Although electrical receptacles were enclosed in weatherproof enclosures, no Ground Fault Circuit Interrupter (GFCI) protection was provided by them. The Inspector recommends updating the existing exterior electrical circuits to include GFCI protection.

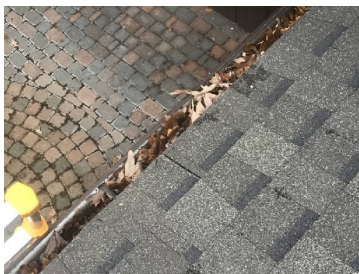
5. Gutters: Aluminum - Debris- Debris visible in the gutters at the time of the inspection should be removed to encourage proper drainage.

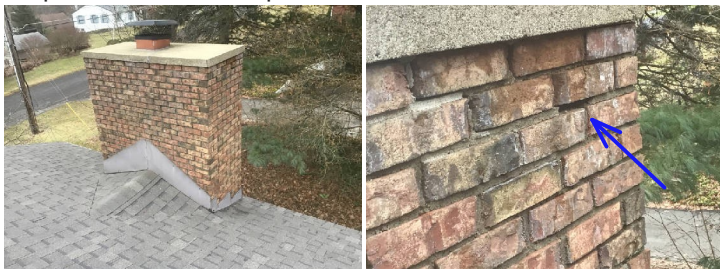
6. Southeast Chimney Chimney: Brick - Mortar joints- The chimney had mortar joints that were missing mortar or damaged. Chimney requires tuck point repairs at various areas. The inspector recommends repair of these areas to prevent moisture penetration.

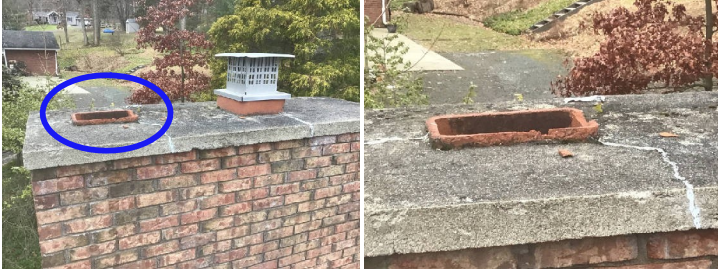
7. Southwest Chimney Flue/Flue Cap: Concrete - Flue height- Flues should extend a minimum of 4 inches above the top of the masonry chimney. The inspector recommends raising flue height to prevent moisture entry into chimney.

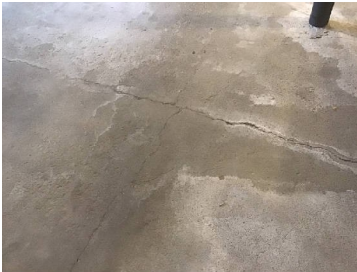
8. Tuck under Garage Floor/Foundation: Poured concrete - Minor floor cracks noted-seal cracks with appropriate sealer.

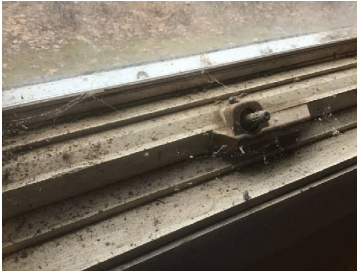
9. Tuck under Garage Windows: Wood casement - Missing cranks- Some casement windows in the home were missing cranks (handles). The inspector recommends repair of these areas and any others found during repair.

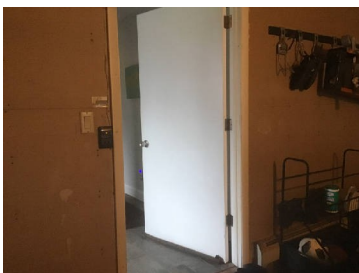
10. Tuck under Garage Service Doors: Metal - Not self closing- The door in the wall between the garage and the home living space did not have operable self-closing hinges as is required by generally-accepted current safety standards. Although it may not have been required at time the home was built it is recommended as a safety upgrade.

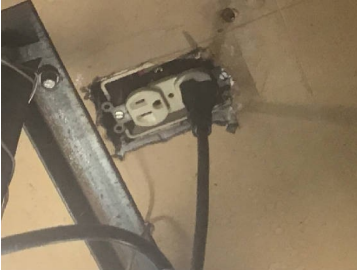
11. Tuck under Garage Electrical: 110 VAC - Missing cover plate- At the time of the inspection, an electrical receptacle or switch cover plate was missing in this room. The inspector recommends repair of these and any others found during repair.

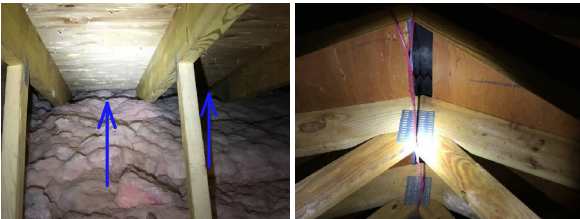
12. South Attic Ventilation: Ridge vents - No attic intake vents- No air intake vents were installed in the attic at the time of the inspection. Intake vents are ventilation devices installed low in the attic roof that introduce cool air to the attic to replace hot air exhausted through ventilation devices installed high in the roof. This airflow through the attic removes excessive heat and moisture. Without a fresh air intakes installed low in the roof, the existing ventilation devices are relatively ineffective. No evidence of any issues as a result of problem at time of inspection. The Inspector recommends that intake ventilation devices be installed low in the roof to improve overall attic ventilation.

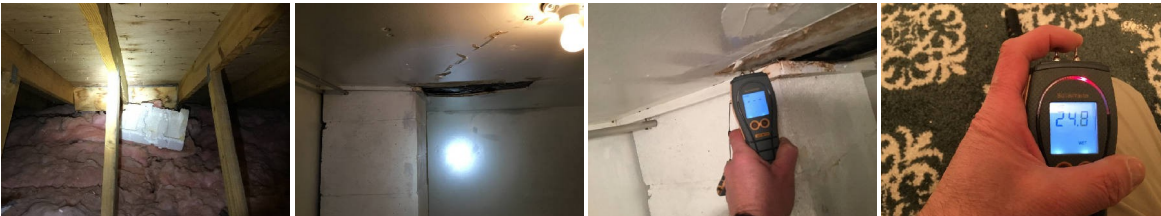
13. North Attic Sheathing: Plywood - Past roof leak- Roof sheathing had areas of discoloration that appeared to be the result of roof leakage. Sheathing did not have elevated moisture levels at the time of the inspection. The source of the leak appeared to have been corrected. Ask current owners for proof of repair.

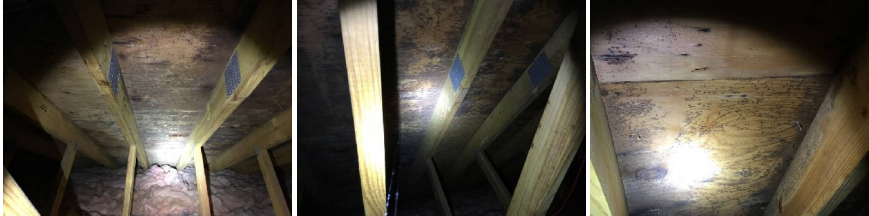
14. North Attic Moisture Penetration: Localized discoloration - Mold like substance, localized- 20x20 section. The attic had areas of discoloration that appeared to be microbial growth, possibly a mold-like substance. Confirming the presence of mold would require laboratory analysis. The Inspector recommends that the source of moisture be identified and the condition corrected.

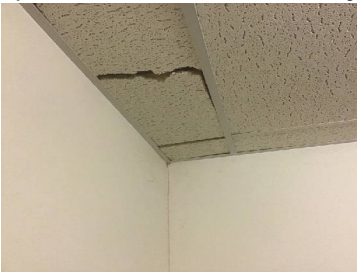
19. Main Basement Ceiling: Suspended ceiling - Limit of inspection- Suspended ceiling present. As a limit of inspection we do not remove ceiling tiles. Hidden problems may exist due to the inability to inspect underlining materials.
Damage- Damage or deterioration to the ceilings was visible at the time of inspection. The inspector recommends repair of these areas and any others found during repair.

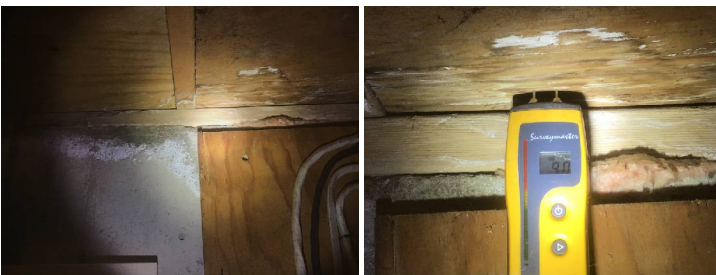
20. Main Basement Moisture Location: Southeast - Efflorescence- In the basement, efflorescence was visible at some of the interior surfaces of the foundation walls. Efflorescence is a white, powdery residue left by moisture seeping through the foundation wall and its presence indicates high moisture levels in soil near the foundation. The source of moisture should be identified and the condition corrected.

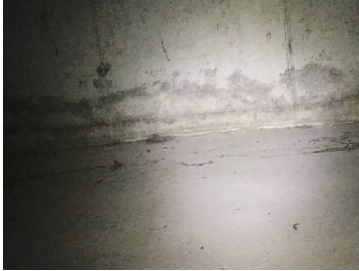
21. North Crawl Space Moisture Penetration: West wall - Mold like substance- no elevated moisture levels- Areas covered with a substance resembling mold. This condition indicates moisture intrusion. Mold can only be positively identified through sampling and analysis by qualified personnel. The moisture meter showed no elevated levels of moisture present at the time of the inspection. This area should be monitored in the future for signs of moisture intrusion and cleaned.

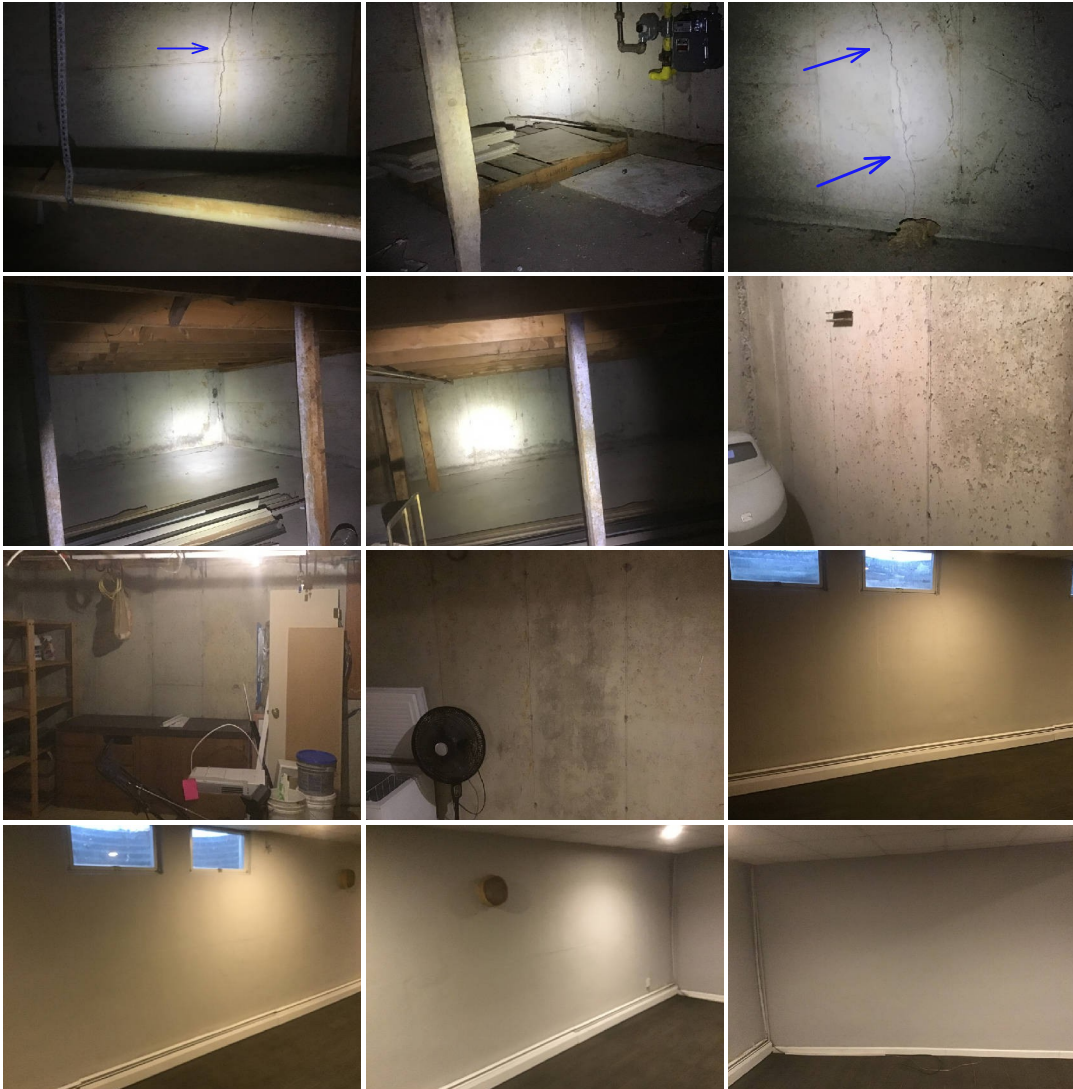
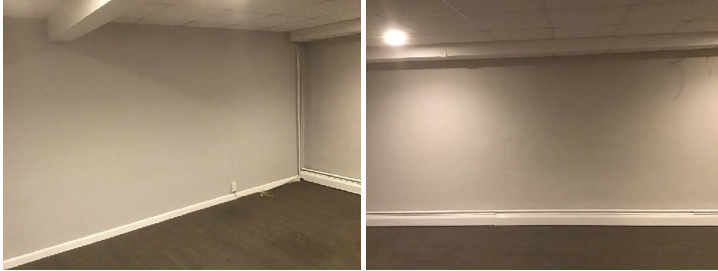
22. Foundation: Poured - Smaller cracks (1/16-1/8)- Cracks visible in the foundation walls appeared to be typical shrinkage cracks that commonly develop as concrete or block cures. Shrinkage cracks are surface cracks and are typically not a structural concern. Sealing or repair of cracks is recommended.

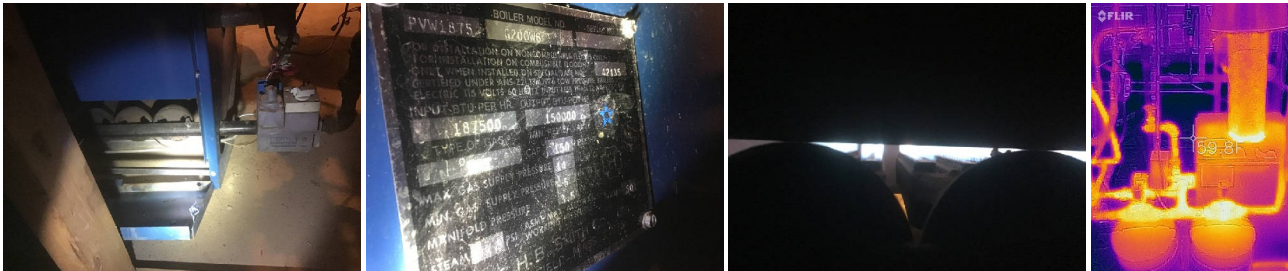
24. Main Heating System Heating System Operation: Adequate - System 30+ years old- The hvac system is functional but likely nearing or beyond its design life. Therefore, it will need to be more closely monitored, it should be serviced annually. Consider having a HVAC technician inspect the heat exchanger and better determine the units remaining life expectancy. With a unit this old it is recommended to budget for replacement.

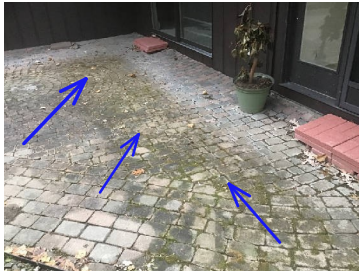
1. Patio: Paver - Settlement- The patio has settled towards the foundation causing a negative slope into the foundation. This may direct water towards foundation. Recommend repair.
Undulations- The patio has undulations that may result in puddling. Use caution during colder periods or patch/repair.

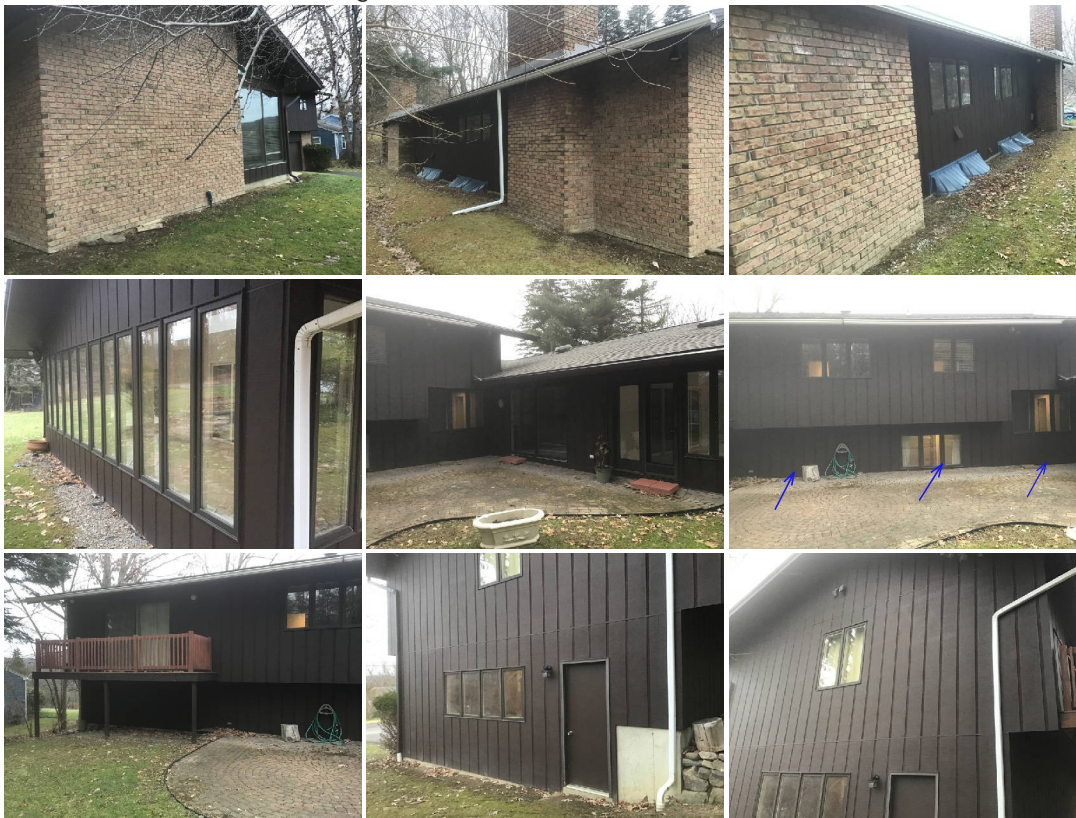
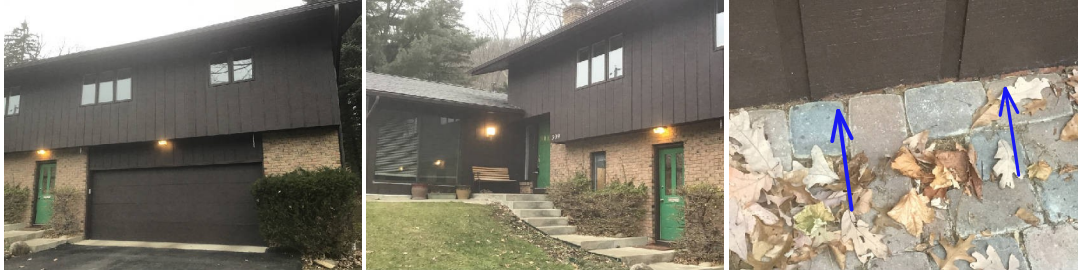
2. Main Exterior Surface Type: Brick, Wood - Clearance- Siding in contact with ground. Recommend maintaining a minimum of 6 inches from grade to avoid related concerns. Correction is recommended.

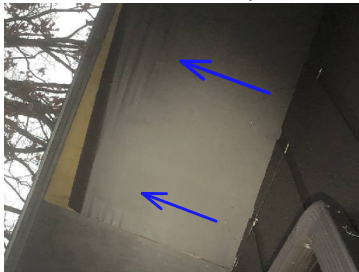
3. Soffits: Plywood - Moderate- Areas at the home exhibited moderate weathering and deterioration. Repair and maintenance is required in some areas.

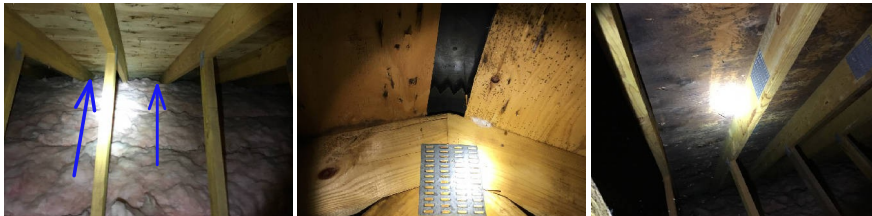
4. North Attic Ventilation: Ridge vents - No attic intake vents- No air intake vents were installed in the attic at the time of the inspection. Intake vents are ventilation devices installed low in the attic roof that introduce cool air to the attic to replace hot air exhausted through ventilation devices installed high in the roof. This airflow through the attic removes excessive heat and moisture. Without a fresh air intakes installed low in the roof, the existing ventilation devices are relatively ineffective. Evidence of improper ventilation is present. The Inspector recommends that intake ventilation devices be installed low in the roof to improve overall attic ventilation.

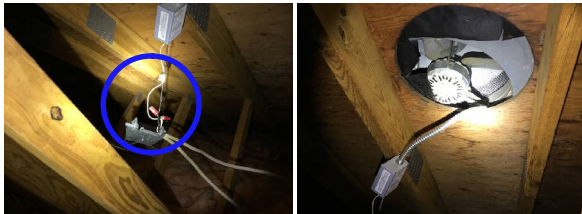
5. North Attic Attic Fan: Thermostat controlled - Exposed wiring present and requires evaluation and repair.

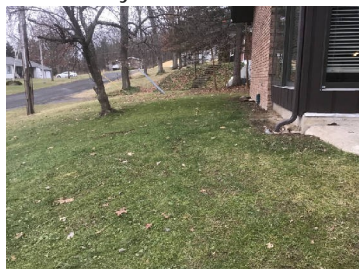
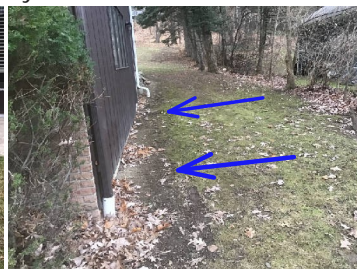
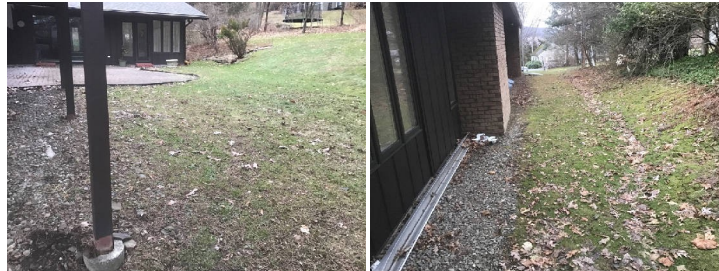
4. Maintenance/Home Improvement Grading: Minor slope, Flat - Flat- The grading is flat in some areas, use caution and monitor for pooling against foundation. Improvement of grade may be necessary to direct water away from the structure.

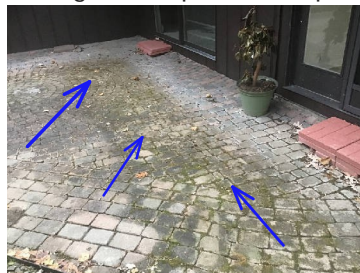
Patio: Paver - Settlement- The patio has settled towards the foundation causing a negative slope into the foundation. This may direct water towards foundation. Recommend repair.

Undulations- The patio has undulations that may result in puddling. Use caution during colder periods or patch/repair.

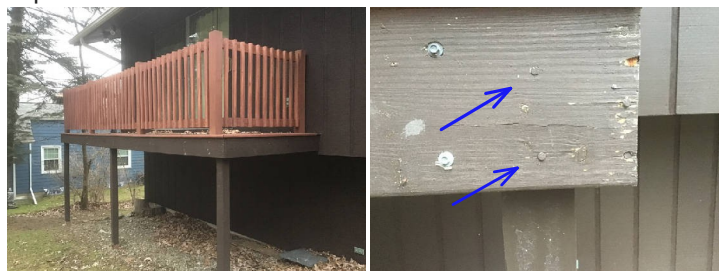
Balcony: Stained wood - No Flashing- No flashing is visible at ledger board of deck. This condition may allow water to be trapped between deck and structure. It is very difficult to add flashing after deck is built and may have not been required when constructed. The inspector recommends diligently monitoring for moisture and/or installation of flashing.

Support attachment- Improper attachment to supports. Lag bolts or screws are typically used to attach to any structural supports. The inspector recommends repair as directed.

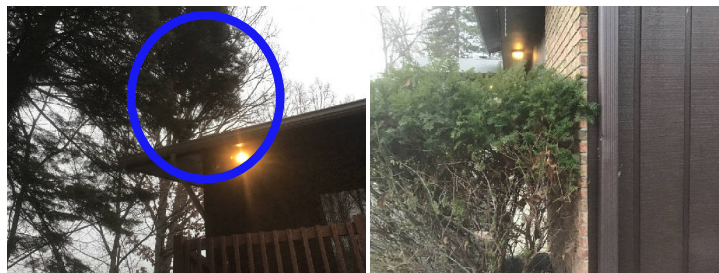
Vegetation: Trees, Shrubs - Overhanging limbs- Tree limbs over hang the roof and should be cut back. Tree cover can cause early failure of roof surface and damage from falling limbs. The inspector recommends trimming limbs. Overgrown- Vegetation around the exterior walls was overgrown and close to in contact with structure. Trimming to 18 inch minimum clearance to avoid related concerns is recommended.

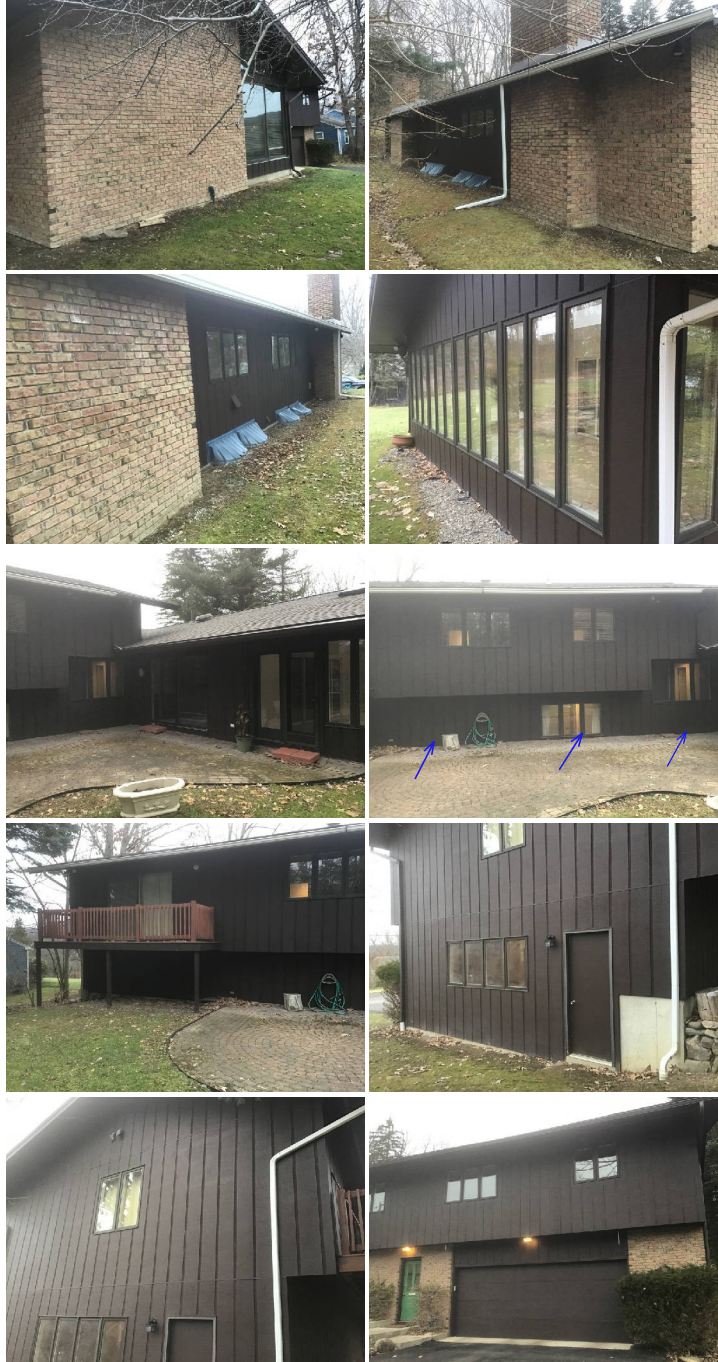
Type: Brick, Wood - Clearance- Siding in contact with ground. Recommend maintaining a minimum of 6 inches from grade to avoid related concerns. Correction is recommended.

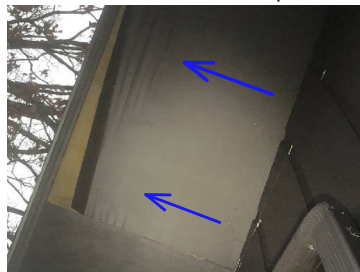
Soffits: Plywood - Moderate- Areas at the home exhibited moderate weathering and deterioration. Repair and maintenance is required in some areas.

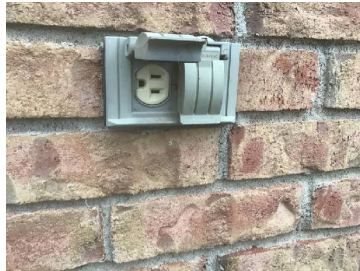
13. Maintenance/Home Improvement Exterior Electric Outlets: 110 VAC - Weather protected, non- GFCI- Although electrical receptacles were enclosed in weatherproof enclosures, no Ground Fault Circuit Interrupter (GFCI) protection was provided by them. The Inspector recommends updating the existing exterior electrical circuits to include GFCI protection.

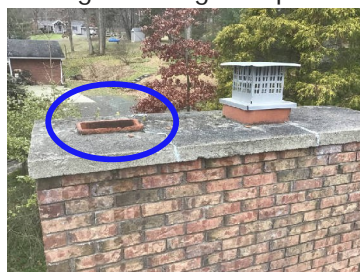
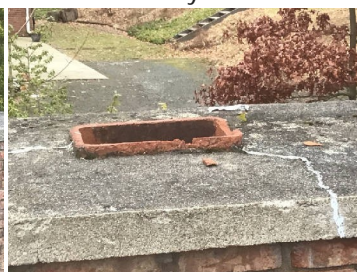
21. Maintenance/Home Improvement Flue/Flue Cap: Concrete - Flue height- Flues should extend a minimum of 4 inches above the top of the masonry chimney. The inspector recommends raising flue height to prevent moisture entry into chimney.

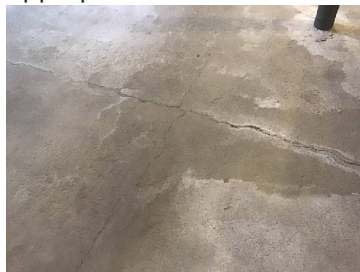
10. Maintenance/Home Improvement Floor/Foundation: Poured concrete - Minor floor cracks noted-seal cracks with appropriate sealer.

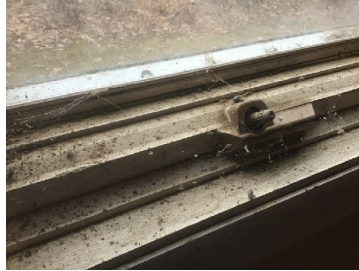
11. Maintenance/Home Improvement Windows: Wood casement - Missing cranks- Some casement windows in the home were missing cranks (handles). The inspector recommends repair of these areas and any others found during repair.

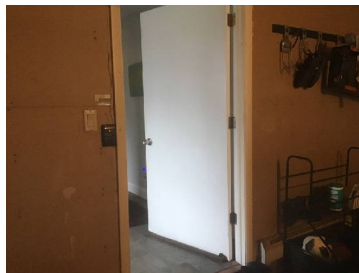
12. Maintenance/Home Improvement Service Doors: Metal - Not self closing- The door in the wall between the garage and the home living space did not have operable self-closing hinges as is required by generally-accepted current safety standards. Although it may not have been required at time the home was built it is recommended as a safety upgrade.

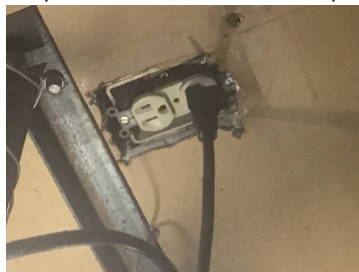
13. Maintenance/Home Improvement Electrical: 110 VAC - Missing cover plate- At the time of the inspection, an electrical receptacle or switch cover plate was missing in this room. The inspector recommends repair of these and any others found during repair.

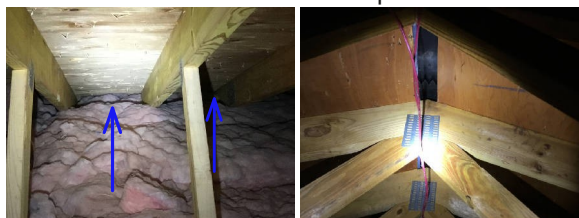
6. Maintenance/Home Improvement Ventilation: Ridge vents - No attic intake vents- No air intake vents were installed in the attic at the time of the inspection. Intake vents are ventilation devices installed low in the attic roof that introduce cool air to the attic to replace hot air exhausted through ventilation devices installed high in the roof. This airflow through the attic removes excessive heat and moisture. Without a fresh air intakes installed low in the roof, the existing ventilation devices are relatively ineffective. No evidence of any issues as a result of problem at time of inspection. The Inspector recommends that intake ventilation devices be installed low in the roof to improve overall attic ventilation.

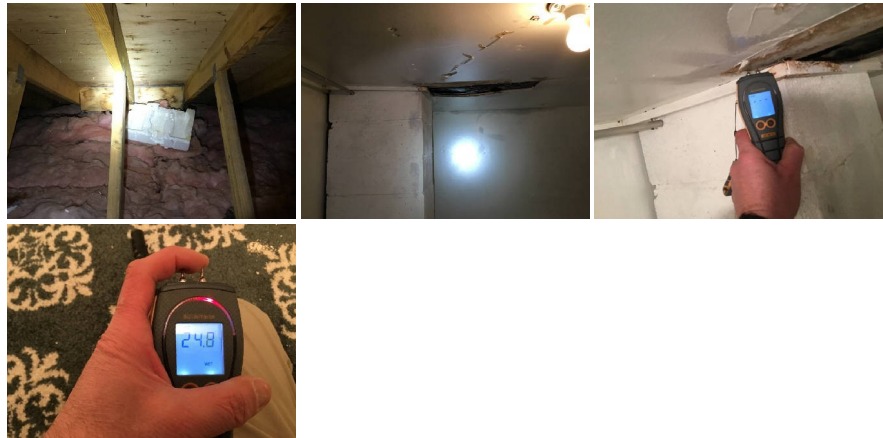
21. Maintenance/Home Improvement Sheathing: Plywood - Past roof leak- Roof sheathing had areas of discoloration that appeared to be the result of roof leakage. Sheathing did not have elevated moisture levels at the time of the inspection. The source of the leak appeared to have been corrected. Ask current owners for proof of repair.

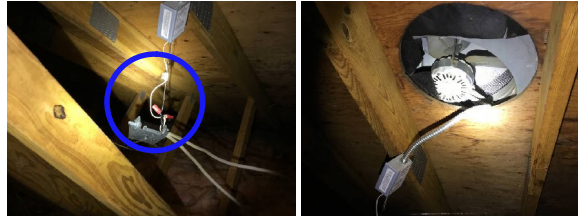
Attic Fan: Thermostat controlled - Exposed wiring present and requires evaluation and repair.

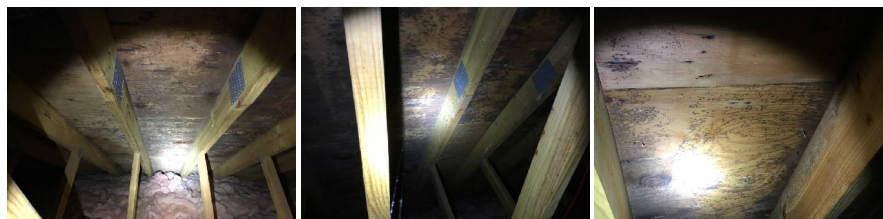
Moisture Penetration: Localized discoloration - Mold like substance, localized- 20x20 section. The attic had areas of discoloration that appeared to be microbial growth, possibly a mold-like substance. Confirming the presence of mold would require laboratory analysis. The Inspector recommends that the source of moisture be identified and the condition corrected.

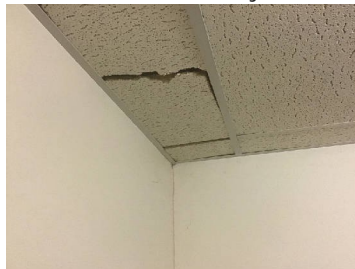
- 1. Inspected
- 2. Not Inspected, Maintenance/Home Improvement Ceiling: Suspended ceiling - Limit of inspection- Suspended ceiling present. As a limit of inspection we do not remove ceiling tiles. Hidden problems may exist due to the inability to inspect underlining materials.
Damage- Damage or deterioration to the ceilings was visible at the time of inspection. The inspector recommends repair of these areas and any others found during repair.

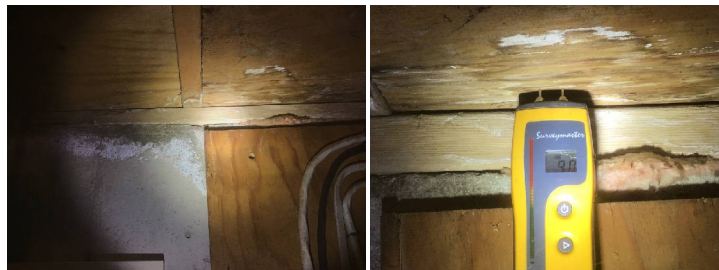
15. Maintenance/Home Improvement Moisture Location: Southeast - Efflorescence- In the basement, efflorescence was visible at some of the interior surfaces of the foundation walls. Efflorescence is a white, powdery residue left by moisture seeping through the foundation wall and its presence indicates high moisture levels in soil near the foundation. The source of moisture should be identified and the condition corrected.

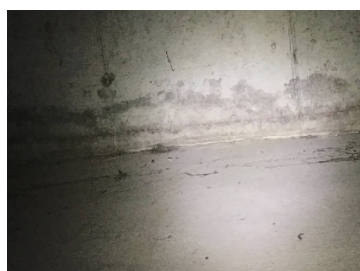
1. Method of Inspection: In the crawl space
2. Inspected Unable to Inspect: 10%
3. Inspected Access: Open
4. Maintenance/Home Improvement Moisture Penetration: West wall - Mold like substance- no elevated moisture levels- Areas covered with a substance resembling mold. This condition indicates moisture intrusion. Mold can only be positively identified through sampling and analysis by qualified personnel. The moisture meter showed no elevated levels of moisture present at the time of the inspection. This area should be monitored in the future for signs of moisture intrusion and cleaned.

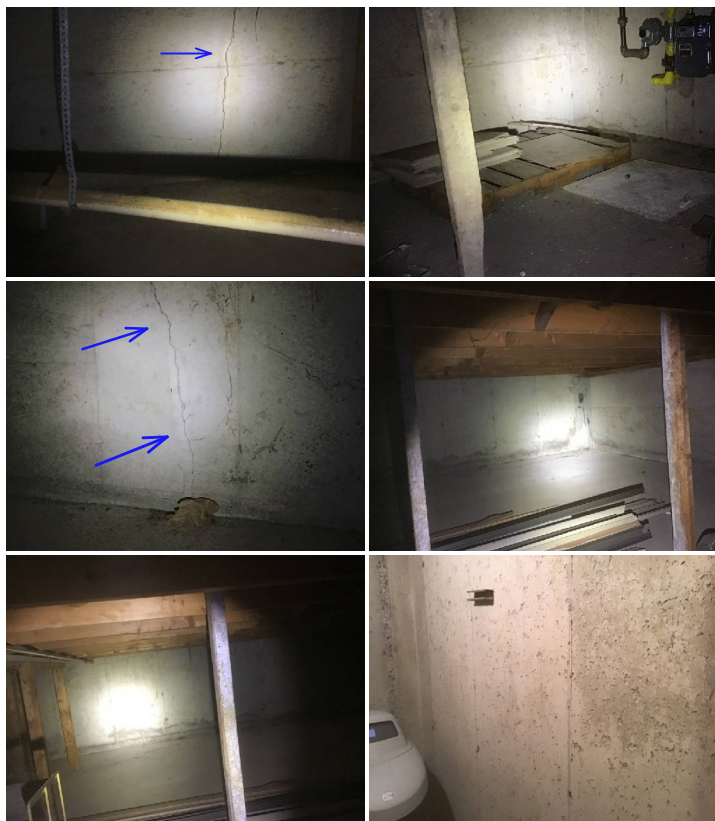
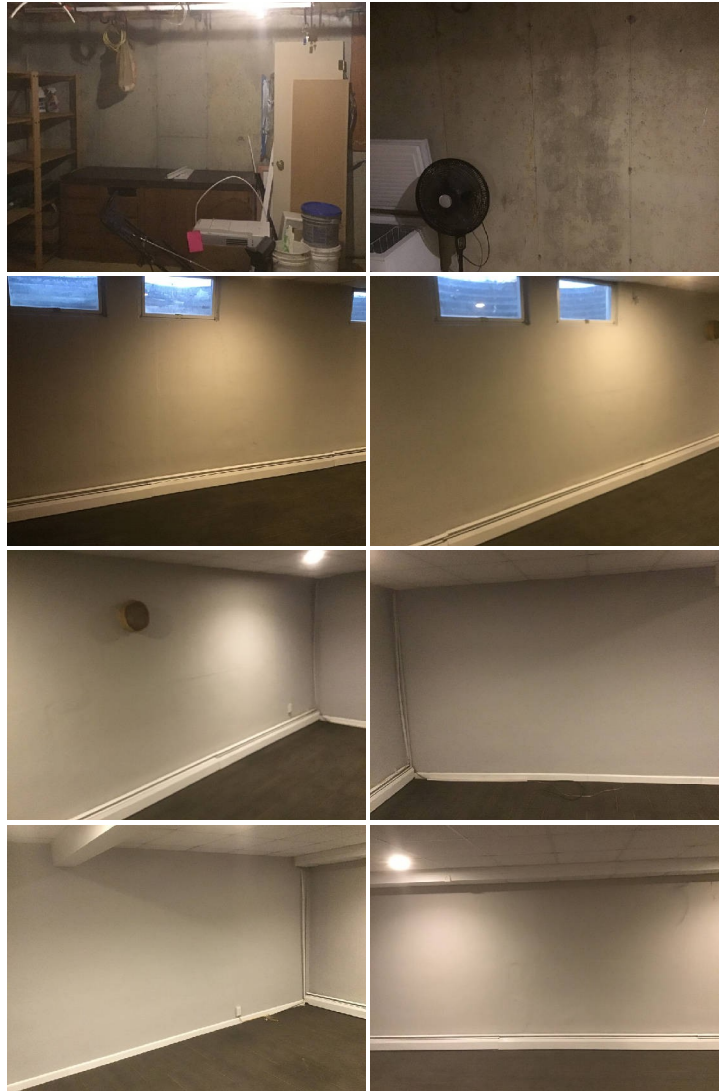
| 2. Maintenance/Home Improvement | Foundation: Poured - Smaller cracks (1/16-1/8)- Cracks visible in the foundation walls appeared to be typical shrinkage cracks that commonly develop as concrete or block cures. Shrinkage cracks are surface cracks and are typically not a structural concern. Sealing or repair of cracks is recommended. |

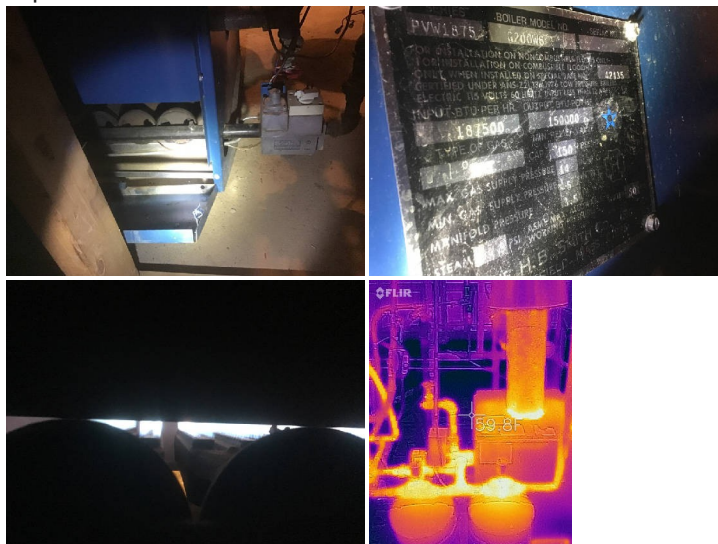
1. Maintenance/Home Improvement Heating System Operation: Adequate - System 30+ years old- The hvac system is functional but likely nearing or beyond its design life. Therefore, it will need to be more closely monitored, it should be serviced annually. Consider having a HVAC technician inspect the heat exchanger and better determine the units remaining life expectancy. With a unit this old it is recommended to budget for replacement.
