Property Inspection Report

123 Somewhere St
Yourtown NY 14999

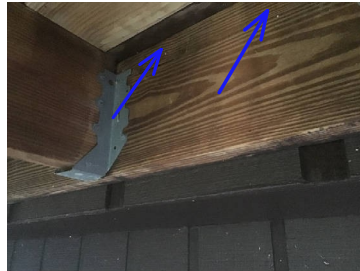
2. Balcony: Stained wood - No Flashing- No flashing is visible at ledger board of deck. This condition may allow water to be trapped between deck and structure. It is very difficult to add flashing after deck is built and may have not been required when constructed. The inspector recommends diligently monitoring for moisture and/or installation of flashing.

Support attachment- Improper attachment to supports. Lag bolts or screws are typically used to attach to any structural supports. The inspector recommends repair as directed.

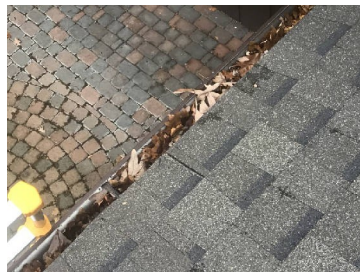
11. Maintenance/Home Improvement Gutters: Aluminum - Debris- Debris visible in the gutters at the time of the inspection should be removed to encourage proper drainage.

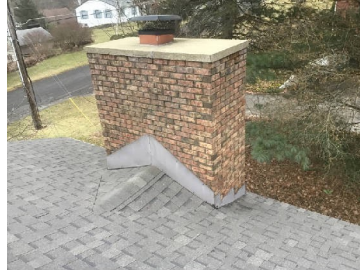
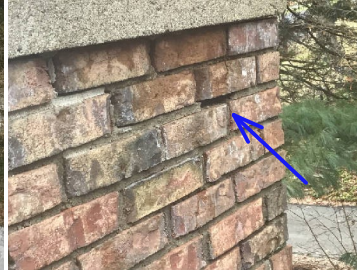
6. Southeast Chimney Chimney: Brick - Mortar joints- The chimney had mortar joints that were missing mortar or damaged. Chimney requires tuck point repairs at various areas. The inspector recommends repair of these areas to prevent moisture penetration.

17. Maintenance/Home Improvement Chimney: Brick - Mortar joints- The chimney had mortar joints that were missing mortar or damaged. Chimney requires tuck point repairs at various areas. The inspector recommends repair of these areas to prevent moisture penetration.

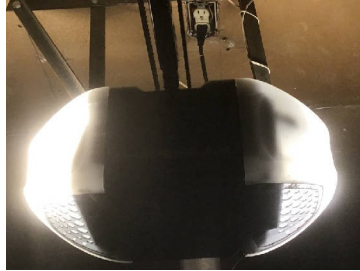
6. Inspected

Door Opener: Chamberlain

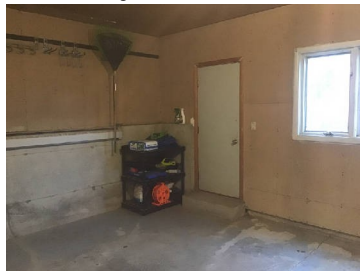
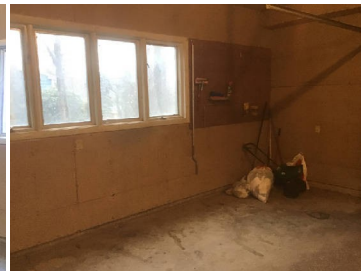
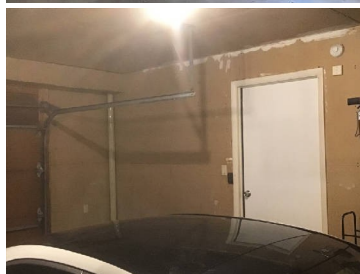
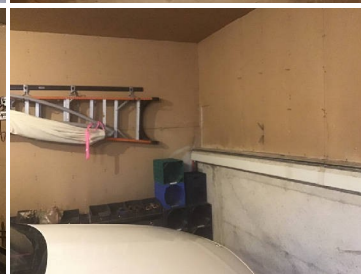
9. Inspected

Walls: Drywall

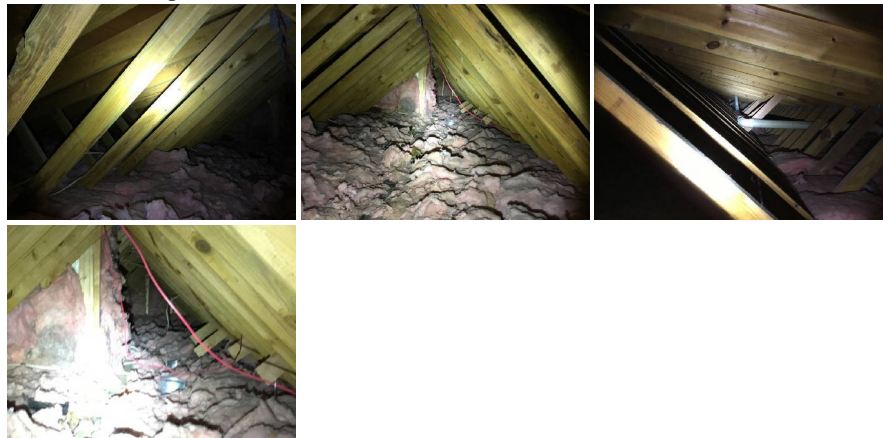
Unable to Inspect: 30% - The attic space lacked adequate headroom for safe entry and a limited inspection was performed from the hatch. The Inspector disclaims responsibility for inspection of roof framing and its components that were not readily observable from the hatch.

Attic Access Skuttle hole, Closet
Roof Framing: 2x6 Truss

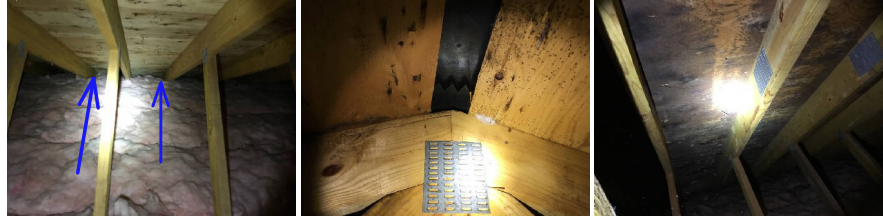
22. Defective- Repair/Replace

Ventilation: Ridge vents - No attic intake vents- No air intake vents were installed in the attic at the time of the inspection. Intake vents are ventilation devices installed low in the attic roof that introduce cool air to the attic to replace hot air exhausted through ventilation devices installed high in the roof. This airflow through the attic removes excessive heat and moisture. Without a fresh air intakes installed low in the roof, the existing ventilation devices are relatively ineffective. Evidence of improper ventilation is present. The Inspector recommends that intake ventilation devices be installed low in the roof to improve overall attic ventilation.

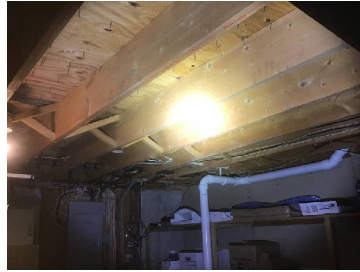
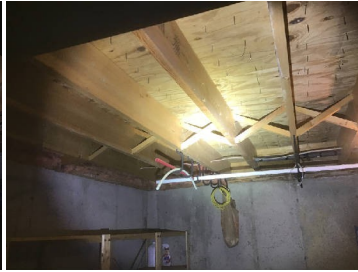
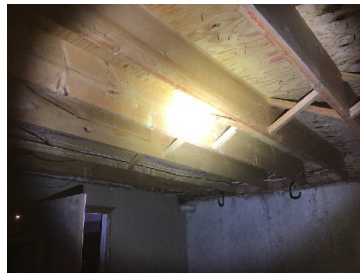
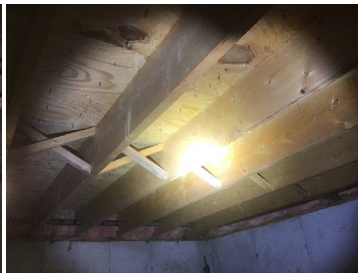
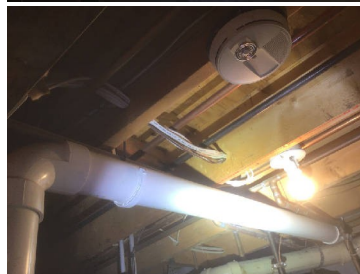
Joists/Trusses: 2x10 - Limit of inspection- Majority of floor joists are hidden by finishes. Report only reflects exposed areas at time of inspection. Hidden problems may exist not documented in this report.

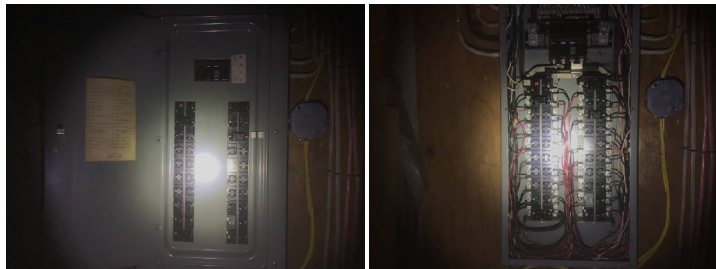
Manufacturer: Gould, Pushmatic

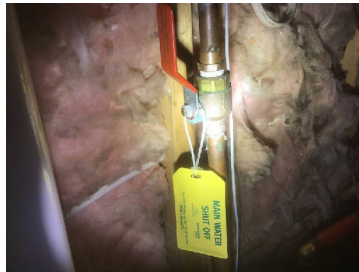
Main Water Shutoff: Basement

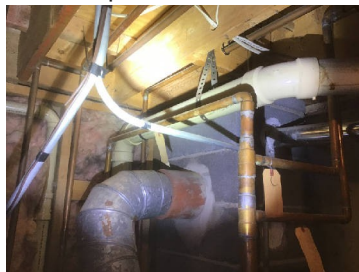
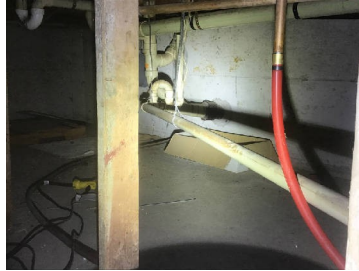
Drain Pipes: PVC

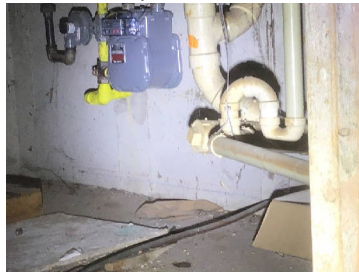
Service Caps: Accessible

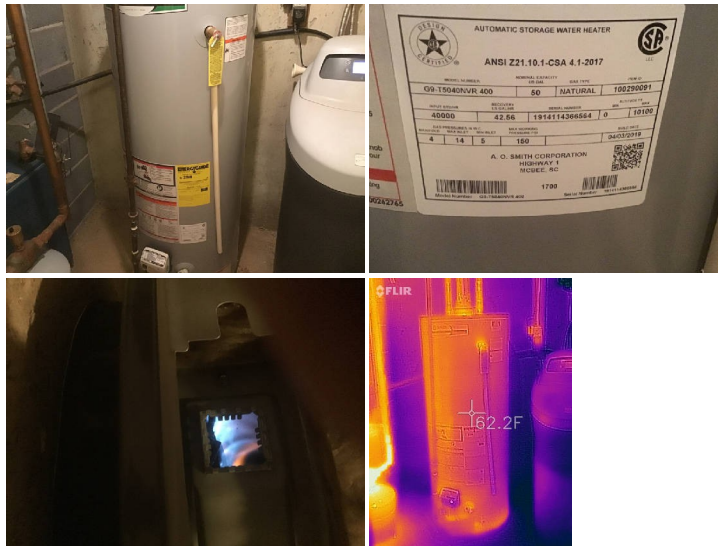
Water Heater Operation: Functional at time of inspection - **As a positive feature this home has a newer hot water heater installed. Visit <https://www.nachi.org/life-expectancy.htm> to learn more about life expectancy of various home materials.**

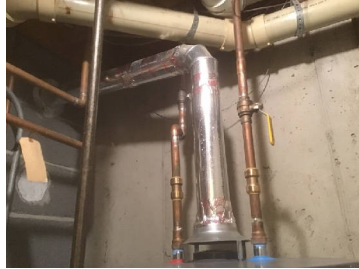
Flue Pipe: Single wall

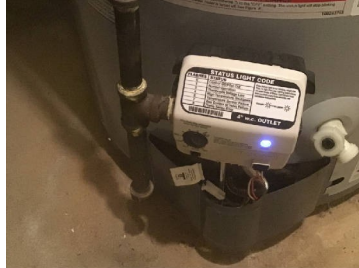
Gas piping Black Iron

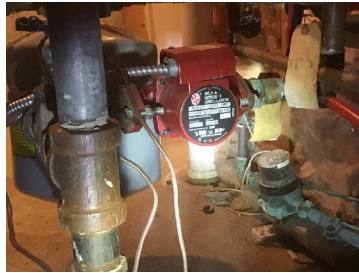
Gas Connection Black Steel

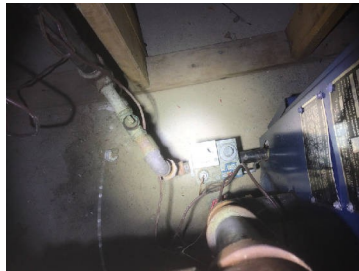
TPRV and Drain Tube Copper

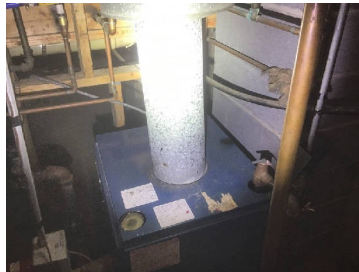
Flue Pipe: Single wall

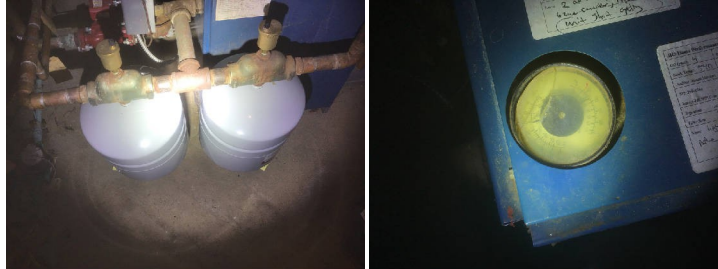
Devices: Temp gauge, Expansion tank, Pressure gauge
